**Flood Control Project Maintenance
Levee Inspections**

2013 Channel Summary Report

Fairfield Suisun Sewer District

Flood Control Project Maintenance**Unit Cover Sheet****2013 Channel Inspection Results****Fairfield Suisun Sewer District**

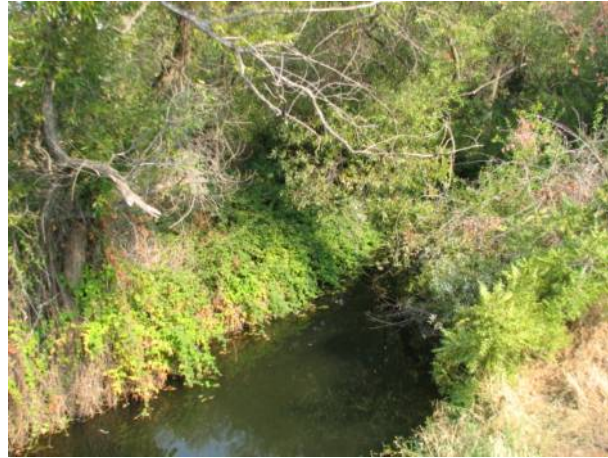
johngw_c_20130822_085.JPG

Looking upstream at Manual Campos Drive.
(Summer 2013)

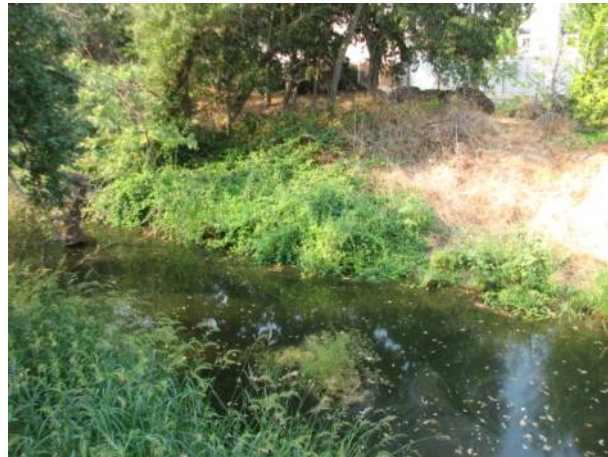
johngw_c_20130822_086.JPG

Looking downstream at Manual Campos Drive
(Summer 2013)

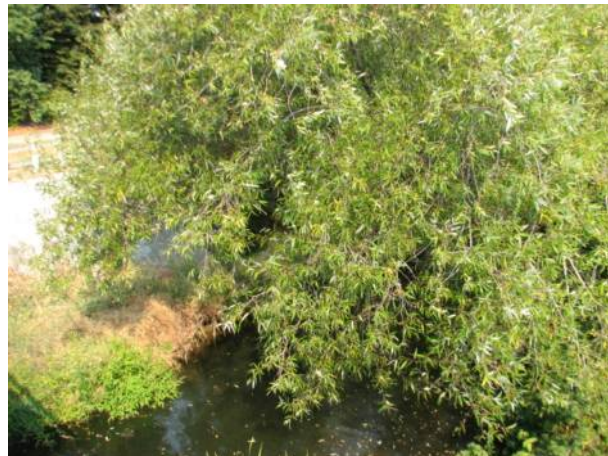
johngw_c_20130822_087.JPG

Looking upstream at Dickson Hill Road (Summer 2013)

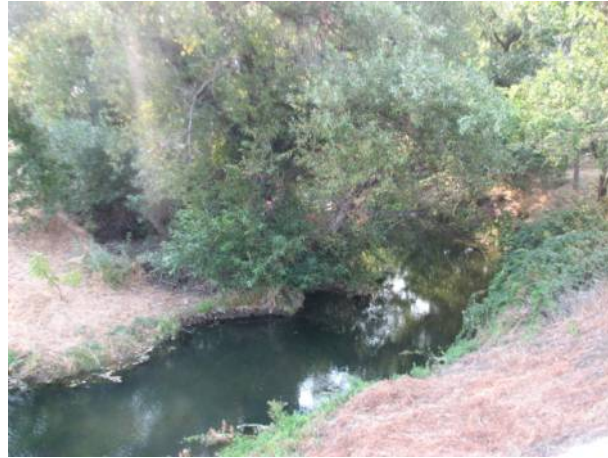
johngw_c_20130822_088.JPG

Looking downstream at Dickson Hill Road
(Summer 2013)

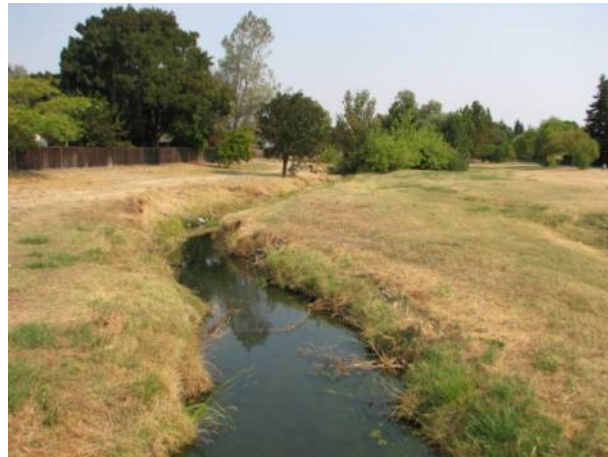
johngw_c_20130822_089.JPG

Looking upstream at Gulf Drive (Summer 2013)

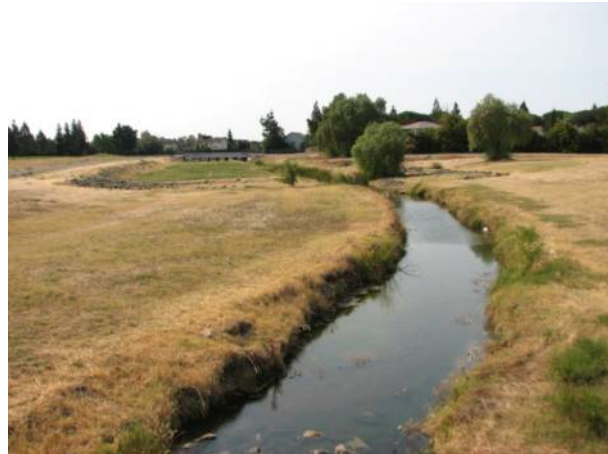
johngw_c_20130822_090.JPG

Looking downstream at Gulf Drive (Summer 2013)

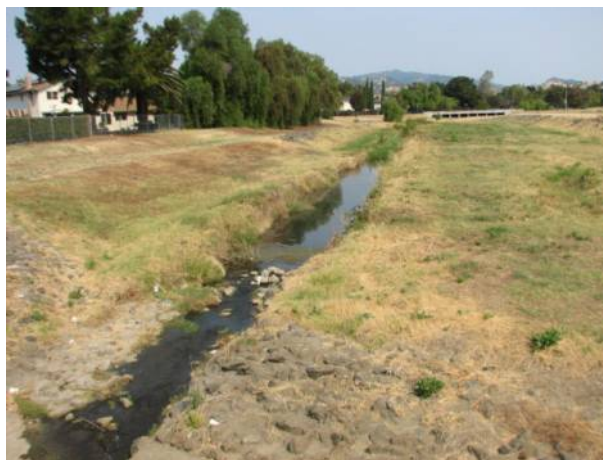
johngw_c_20130822_091.JPG

Looking upstream at Cement Hill Road (Summer 2013)

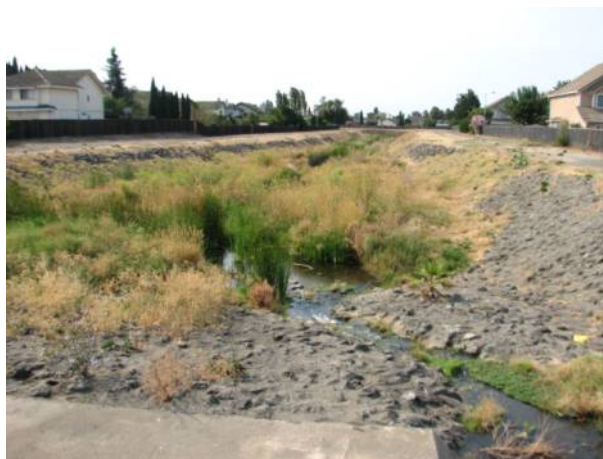
johngw_c_20130822_092.JPG

Looking downstream at Cement Hill Road (Summer 2013)

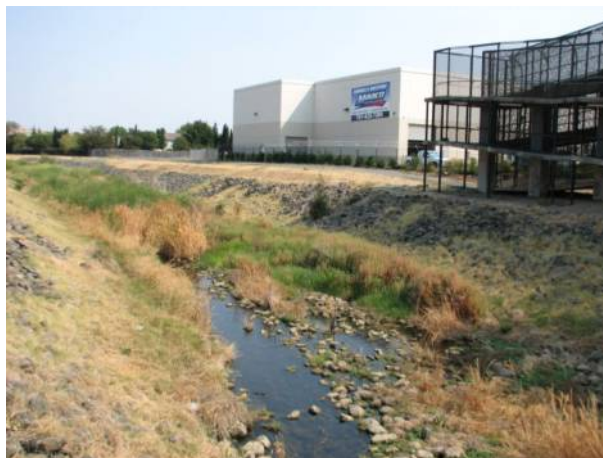
johngw_c_20130822_093.JPG

Looking upstream at Air Base Parkway (Summer 2013)

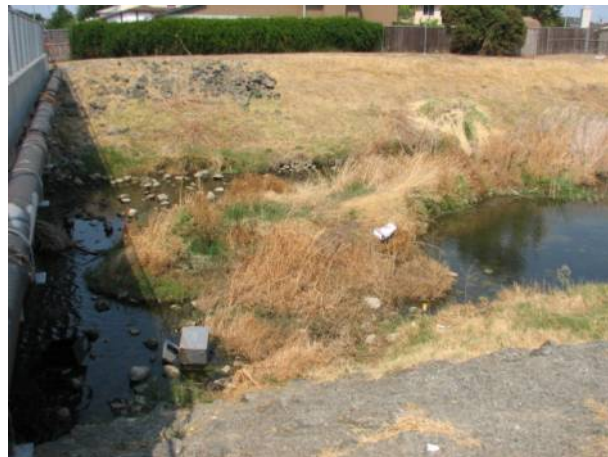
Levee Mile Report Line	42
Start Levee Mile	0.00
End Levee Mile	0.00
Location	
Category	Channels
Item	Shoaling / Sedimentation
A built up of sedimentation upstream suggest removing it. (Summer 2013)	
johngw_c_20130822_101.JPG

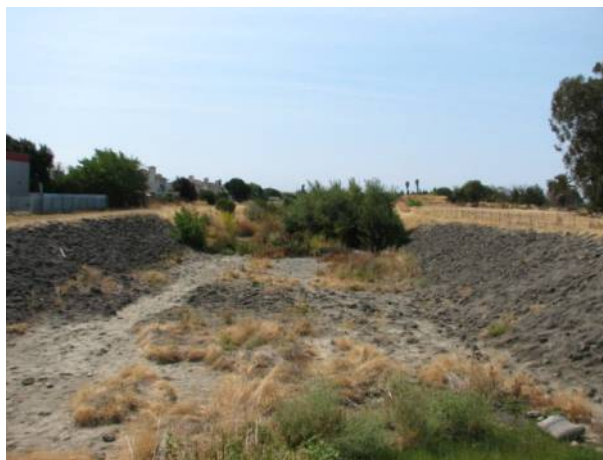
LMR No.	Check Point	View	Item	Location	Rating	Inspector Comment	GPS Latitude & Longitude	Photo	Issue No
51	Railroad Ave	Down	Vegetation & Obstructions		M	Inspector Comments: Vegetation growth (such as cat tails, bull rushes, bushes or saplings) or other obstructions block approximately 25% of the FCW.	38.257752 ° -122.017769 °	Y	56
52		Down	Shoaling / Sedimentation		A	Inspector Comments: No shoaling or sedimentation present.	38.257752 ° -122.017769 °		57
53		Down	Erosion / Bank Caving		A	Inspector Comments: No erosion encroaching into the channel.	38.257752 ° -122.017769 °		58
54		Down	Revetments		A	Inspector Comments: Existing riprap protection is properly maintained and is undamaged. Riprap clearly visible.	38.257752 ° -122.017769 °		59
55		Down	Encroachments		A	Inspector Comments: No Trash, debris, excavation, structures, or other obstructions present within the project easement area.	38.257752 ° -122.017769 °		60

Levee Mile Report Line	51
Start Levee Mile	0.00
End Levee Mile	0.00
Location	
Category	Channels
Item	Vegetation & Obstructions
Looking downstream at Railroad Avenue suggest removal of woody vegetation (Summer 2013)	
johngw_c_20130822_103.JPG

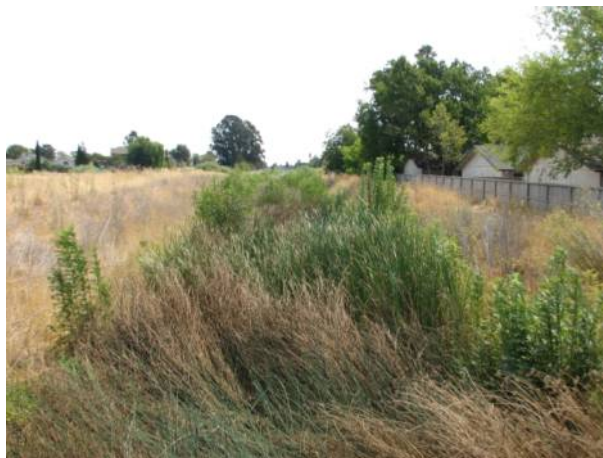
56	SunsetAve	Up	Vegetation & Obstructions		U	Inspector Comments: Vegetation growth (such as cat tails, bull rushes, bushes or saplings) or other obstructions block approximately 50% of the FCW.	38.253409 ° -122.020114 °	Y	61
57		Up	Shoaling / Sedimentation		A	Inspector Comments: No shoaling or sedimentation present.	38.253409 ° -122.020114 °		62
58		Up	Erosion / Bank Caving		A	Inspector Comments: No erosion encroaching into the channel.	38.253409 ° -122.020114 °		63
59		Up	Revetments		M	Inspector Comments: Riprap displacement or scouring activity. Unwanted vegetation must be cleared and sprayed with an appropriate herbicide.	38.253409 ° -122.020114 °		64
60		Up	Encroachments		A	Inspector Comments: No Trash, debris, excavation, structures, or other obstructions present within the project easement area.	38.253409 ° -122.020114 °		65
61		Down	Vegetation & Obstructions		U	Inspector Comments: Vegetation growth (such as cat tails, bull rushes, bushes or saplings) or other obstructions block approximately 50% of the FCW.	38.253409 ° -122.020114 °	Y	66

Levee Mile Report Line	61
Start Levee Mile	0.00
End Levee Mile	0.00
Location	
Category	Channels
Item	Vegetation & Obstructions
Looking downstream at Sunset Avenue suggest removal of woody vegetation and reeds (Summer 2013)	
johngw_c_20130822_105.JPG

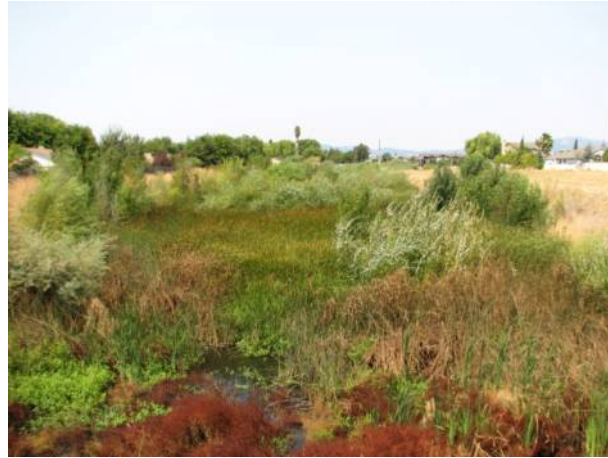
Levee Mile Report Line	66
Start Levee Mile	0.00
End Levee Mile	0.00
Location	
Category	Channels
Item	Vegetation & Obstructions
Looking upstream at Blossom Road suggest removal of woody vegetation (Summer 2013)	
johngw_c_20130822_106.JPG

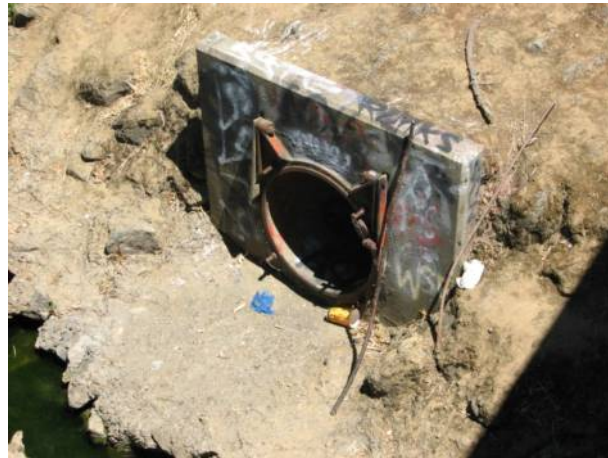
johngw_c_20130702_032.jpg

The flap gate has not been replaced. Should have a new one installed. (2012)

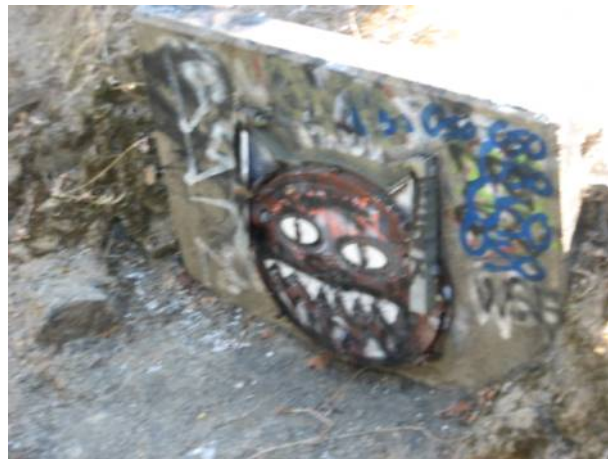
johngw_c_20130822_134.JPG

Flap gate has been replace and tagged (Summer 2013)

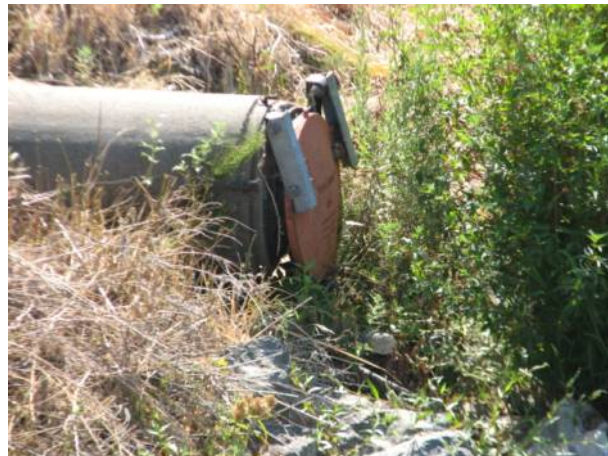
Levee Mile Report Line	36
Start Levee Mile	0.00
End Levee Mile	0.00
Location	
Category	Channels
Item	Vegetation & Obstructions
A flap gate downstream at Auto Mall Parkway needs to be cleaned out and checked (Summer 2013)	
johngw_c_20130822_140.JPG

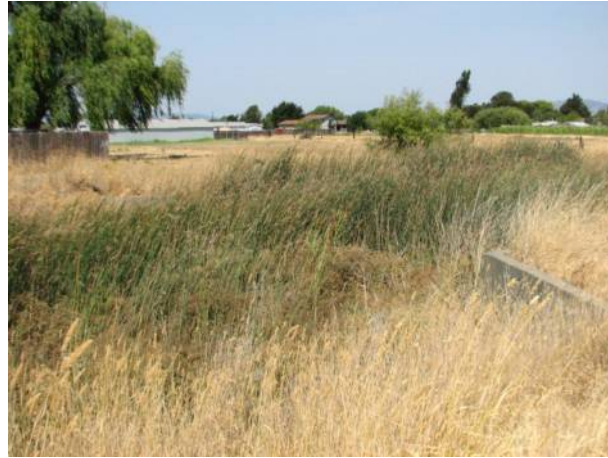
Levee Mile Report Line	1
Start Levee Mile	0.00
End Levee Mile	0.00
Location	
Category	Channels
Item	Vegetation & Obstructions
Looking upstream at Bella Vista Avenue. Cannot see control structure. Suggest removal of tulies. (Summer 2013)	
johngw_c_20130822_117.JPG

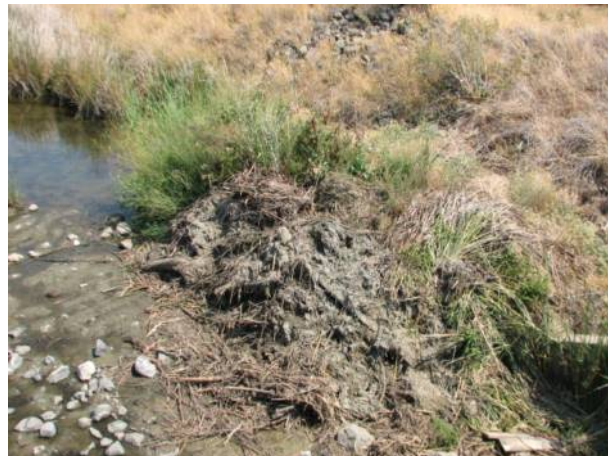
Levee Mile Report Line	22
Start Levee Mile	0.00
End Levee Mile	0.00
Location	
Category	Channels
Item	Shoaling / Sedimentation
Some sedimentation has been pushed to one side but not removed. (Summer 2013)	
johngw_c_20130822_155.JPG
